Minutes of the Eastham Water Management Committee Meeting of January 17, 2018

Aquatic Evaluation at Minister/Schoolhouse Pond

2017 Final Report

EcoLogic Memorandum

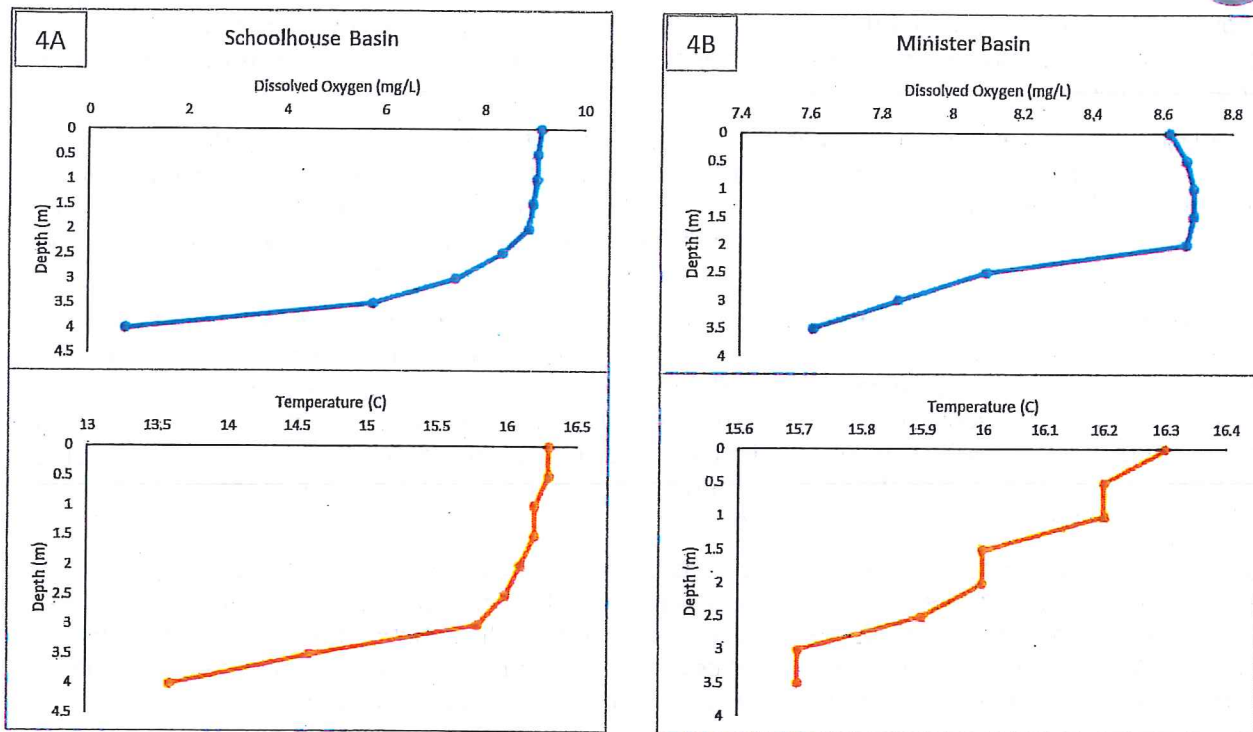
Figure 4A & B: Displays the profiles of Dissolved Oxygen and Temperature throughout the water column, surface to bottom.

At the time of the sampling, stratification had occurred in Schoolhouse basin with a thermocline between 3-3.5 meters depth, whereas the Minister basin was still in the process of mixing/settling.

Dissolved Oxygen (DO) is important in aquatic systems. Aquatic fauna required adequate levels of oxygen, and the pond chemistry is also heavily affected by available oxygen. Values above 5.0 mg/L are desirable for most aquatic life, including most fish species, however lower values commonly occur near the sediment layer where oxygen and nutrient exchange are at a minimum. *See Figure 4 on the following page.*

Temperature – is one of the limiting factors for algae and plant growth; as temperature increases, biological activity (photosynthesis, respiration, and decomposition) increases to a point. Temperature is directly related to the amount of available dissolved oxygen, where warmer water holds less oxygen. In deeper waterbodies, temperature stratification occurs; a thermocline occurs at depth where the top layer is warmer and actively exchanges nutrients with the air. The bottom layer is distinctly cooler and isolated from surface impacts. *See Figure 4 on the following page.*

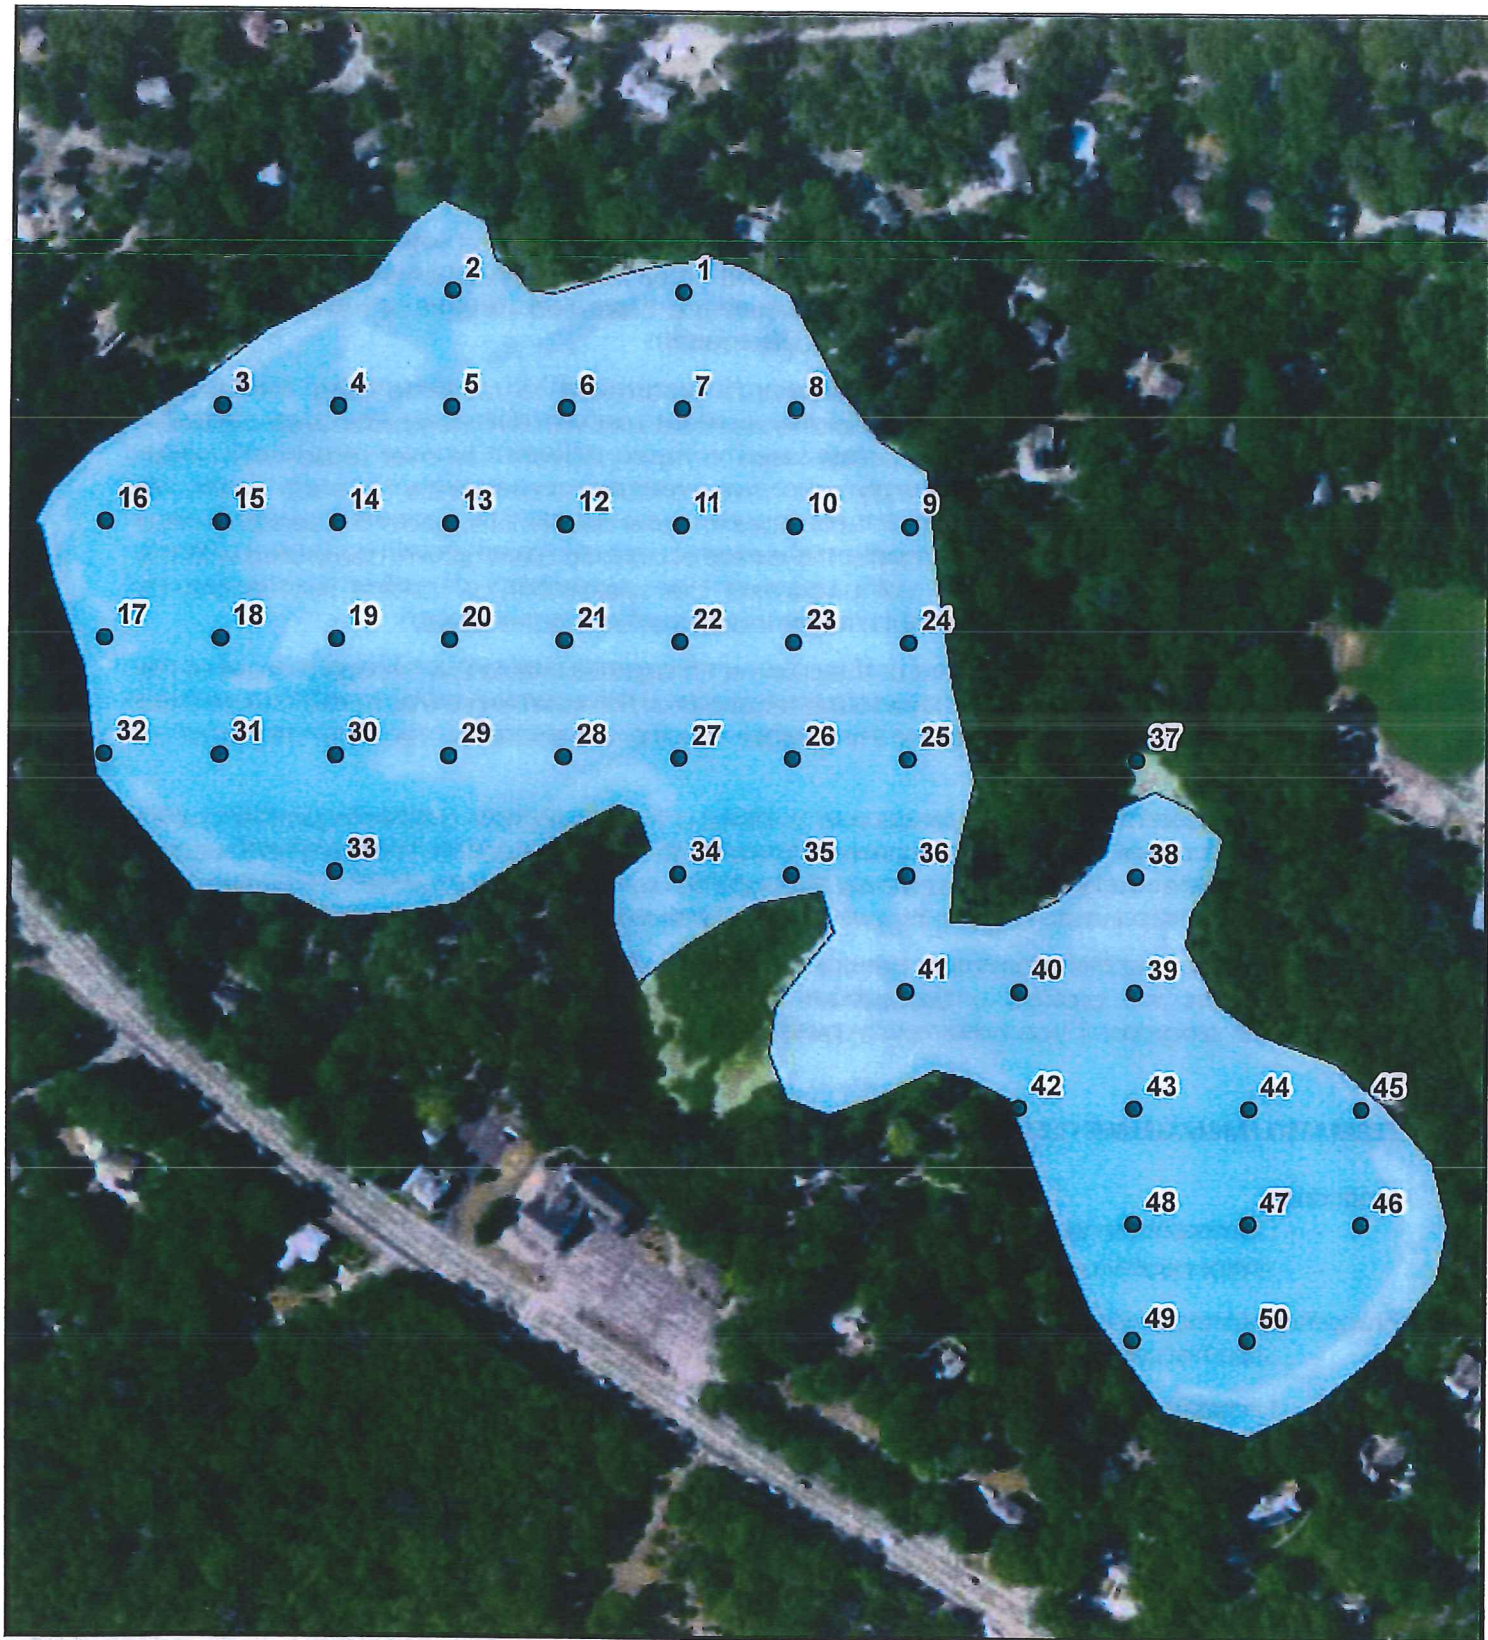
Survey Points

FIGURE:	SURVEY DATE:	MAP DATE:
1	6/7/17	9/8/17

A point-intercept survey methodology was employed to document and quantify aquatic vegetation growth within the waterbody. A georeferenced 40-m grid data layer was placed over an orthophoto of Minister/Schoolhouse Pond and data collection points were placed at each vertex, with a total of fifty (50) representative collection sites (Figure 1). A GPS was used to locate each data point in the field, with the following data collected at each point: aquatic plant species, relative density of each species, and overall density. The abundance scale, developed by the US Army Corps of Engineers and modified by Cornell University, was used to categorize total observed plant growth:

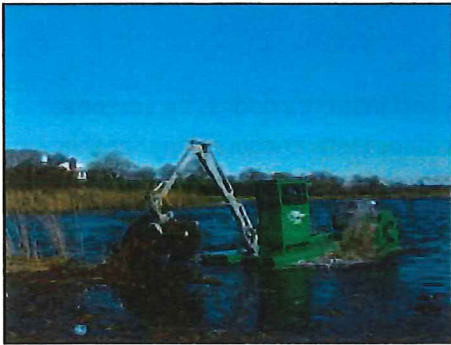
Hydroraking (photo - Allied Biological Inc.)

Massachusetts¹ and other references, hydroraking is a non-selective method of aquatic plant control. Hydroraking uses a floating backhoe-like machine equipped with a raking device that digs into the lake bottom, ripping out plants and their roots along with other benthic material including submerged stumps. This macrophyte control method is particularly effective for water lilies (white or yellow) and other species with dense root masses. Significant sediment resuspension and turbidity, and fragmentation of plants are possible. These machines are generally deployed in areas that are shallow and choked with macrophytes, such as canals, marinas, and embayments. The cost of hydroraking ranges from \$1,500 to \$4,000 per acre. Overall, hydroraking is a costly method that has potential for adverse environmental impacts.

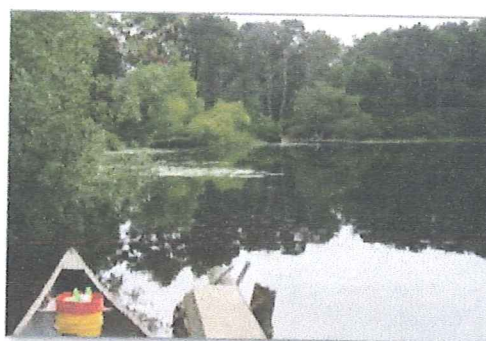
Schoolhouse Pond Water Quality Summary

Water Column	Parameter	Result ¹	"Healthy" Ponds Thresholds ²
Upper Waters	Total Phosphorus	23 µg /l	≤10 µg/l
	Chlorophyll-a	22 µg /l	≤1.7 µg/l
	Secchi Disk Transparency	1.3 m	Not calculated
Lower Waters	Total Phosphorus (<i>maximum average</i>)	65 µg /l	--
	Dissolved Oxygen (<i>minimum average</i>)	0.20 mg/l	--
